Route C3044 / Structure #00045 / (Routine) C3044 over FIRST BRANCH WHITE R.

# Team Lead: Martin Kelley, Inspection Date: 10/26/2023

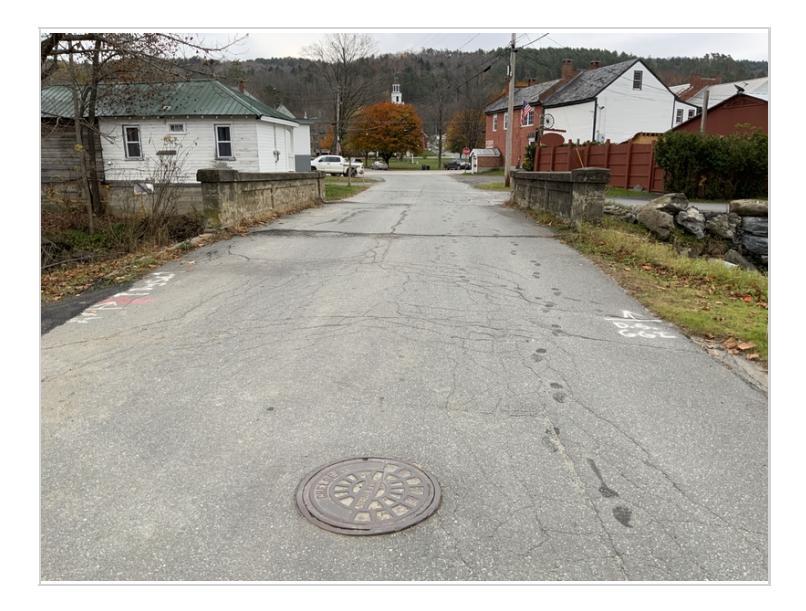
Abutment 1 approach

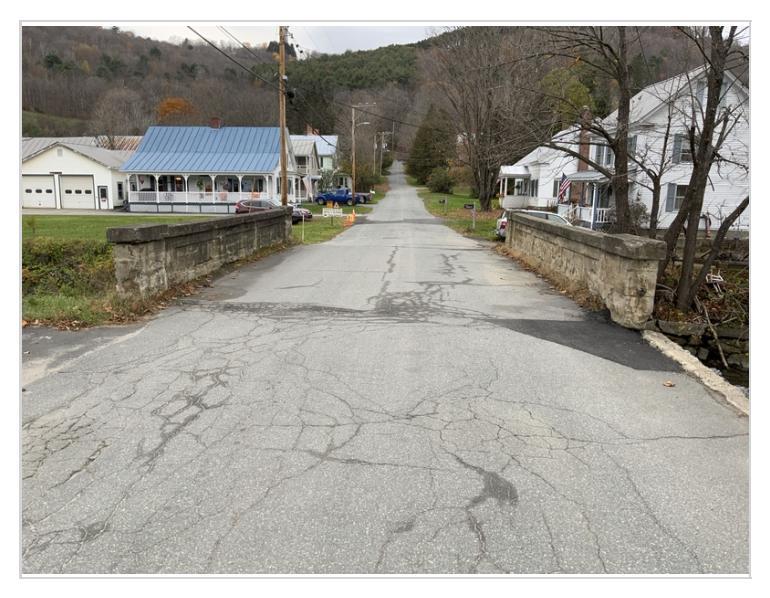
Abutment 2 approach

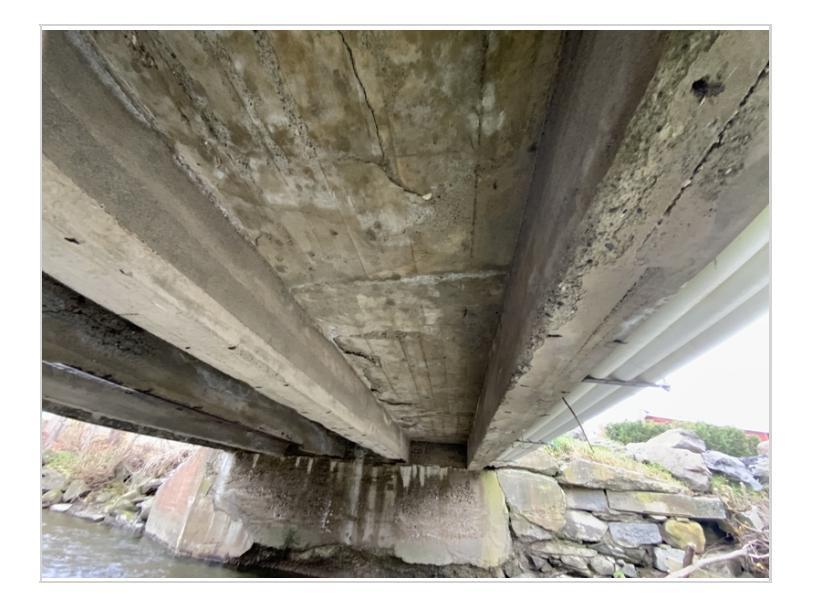
Soffit and beams

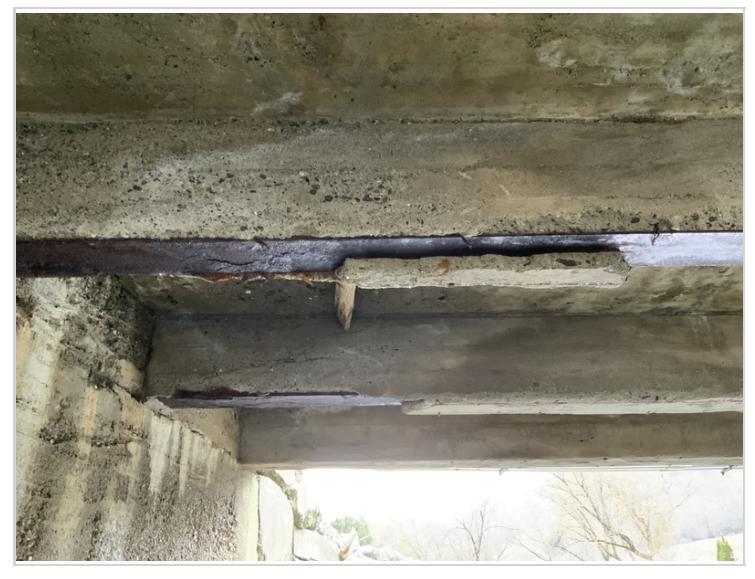
Beams abutment 2

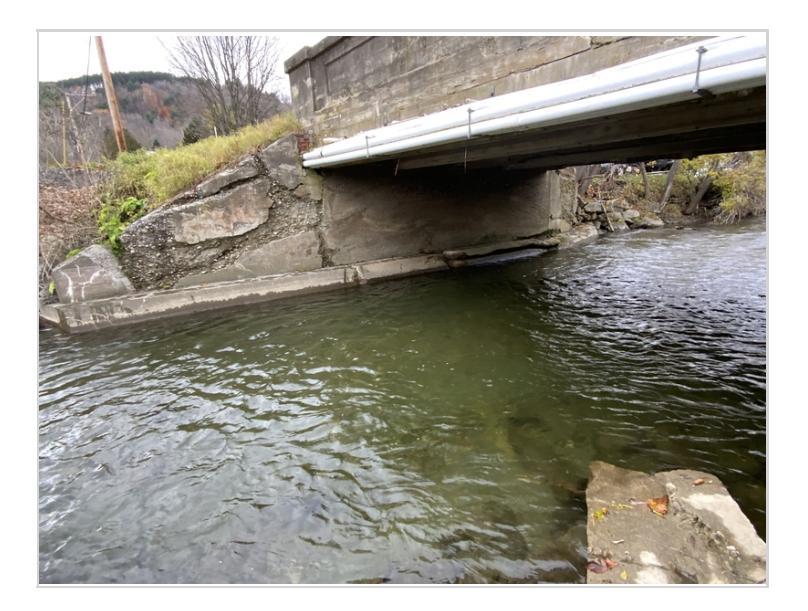
Abutment 2

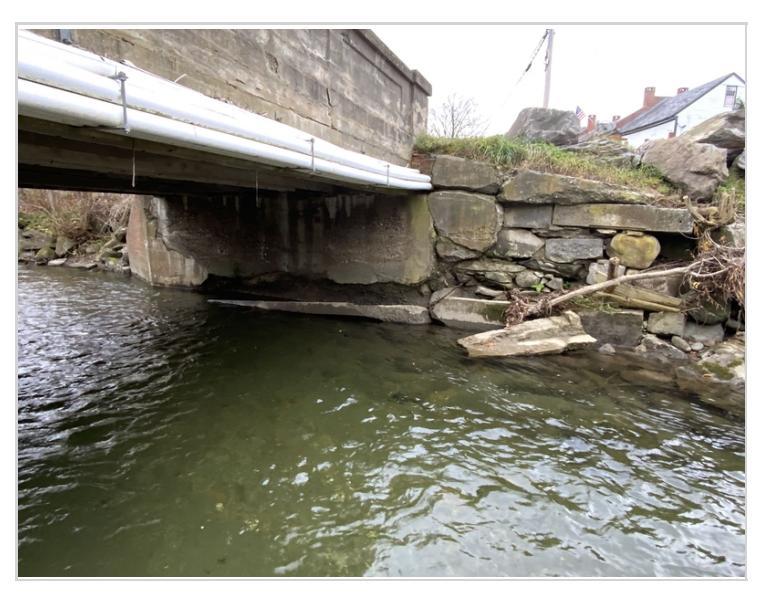
Abutment 1

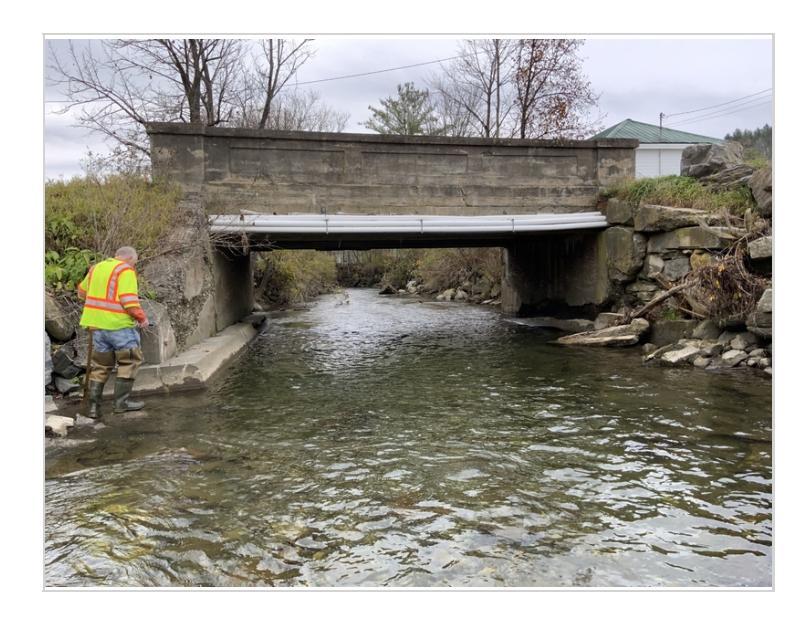
Facing upstream channel

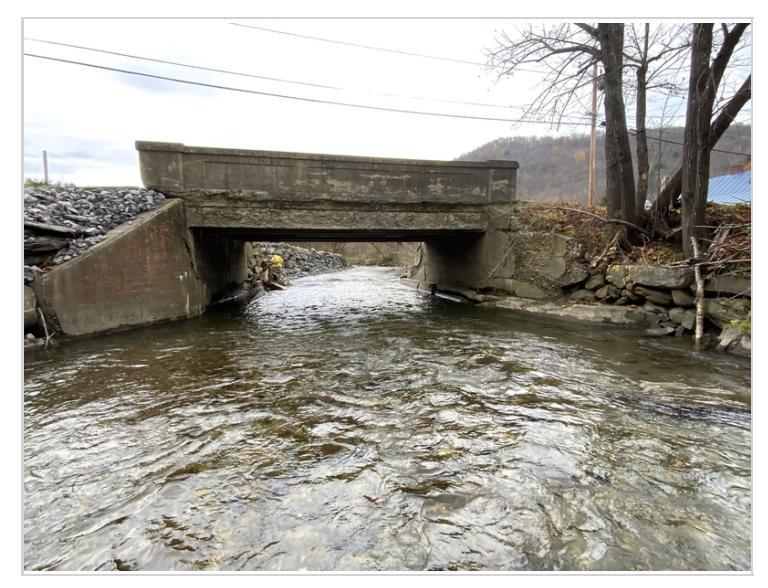
Facing DS channel
